# **DYNAMIC SCIENCE, INC.** In-Depth Accident Investigation

Contract Number DTNH22-94-D-27058 Case Number DSI-94-AB-020

#### **TECHNICAL SUMMARY**

Case DSI-94-AB-20

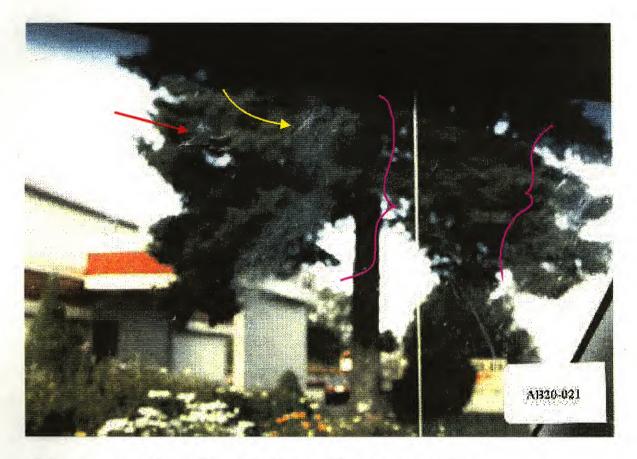
## Photograph #21 (Police Photograph)

There are smudge marks on the windshield from the powder residue of the airbag.

The red arrow is pointing to an unknown object that is embedded on the windshield. It probably came from the "backing" paper that some air bags are "wrapped" in. An exemplar vehicle was inspected, and this "backing" paper was present. It was torn and present behind the air bag module.

Neither the smudge marks or the object were visible when Vehicle 1 was inspected.

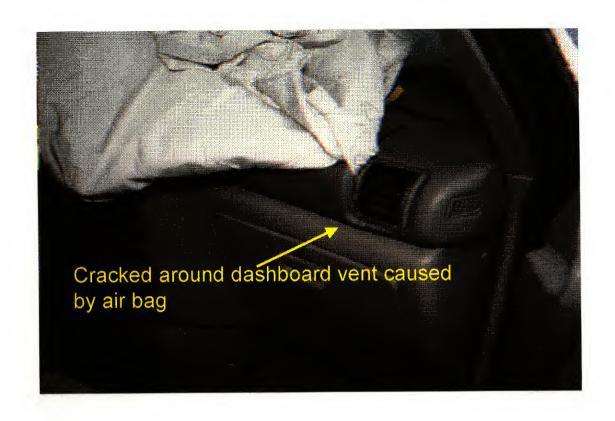
located on the left half of the air bag, whose source could not be identified. There were also blood stains on both of the air bags in the lower left corners that were most likely the result of post-crash bleeding by occupant 2, the right front occupant. This probably occurred when the driver of Vehicle 1 pulled the R/F occupant out the left front door and laid her on the ground.

The right front occupant was the source of the bleeding
